February 2001

# Mill Creek

Flood Control Project  
Radial Gate Investigations

13. ABSTRACT (Maximum 200 words) This report is an evaluation of the overall condition of the spillway tainter gates at Mill Creek Flood Control Project, Walla Walla, Washington

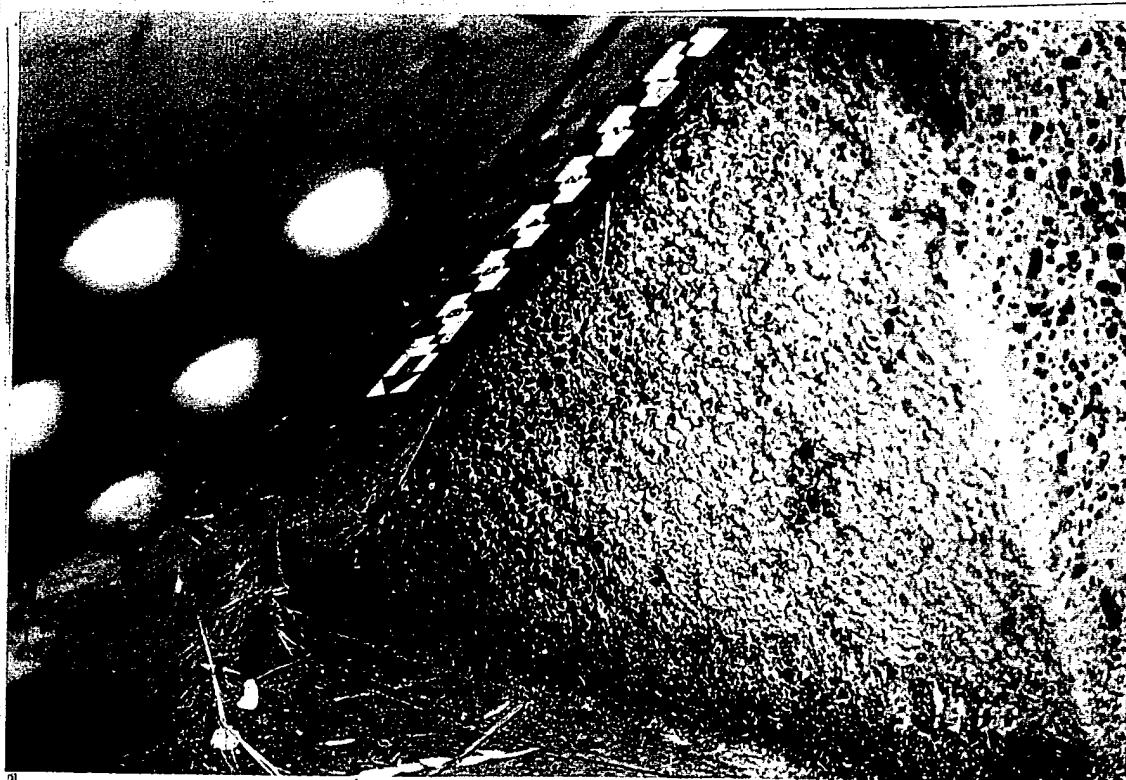
Bottom left corner, splintered timber  
bumper, small deformation and light  
corrosion in bottom strut.

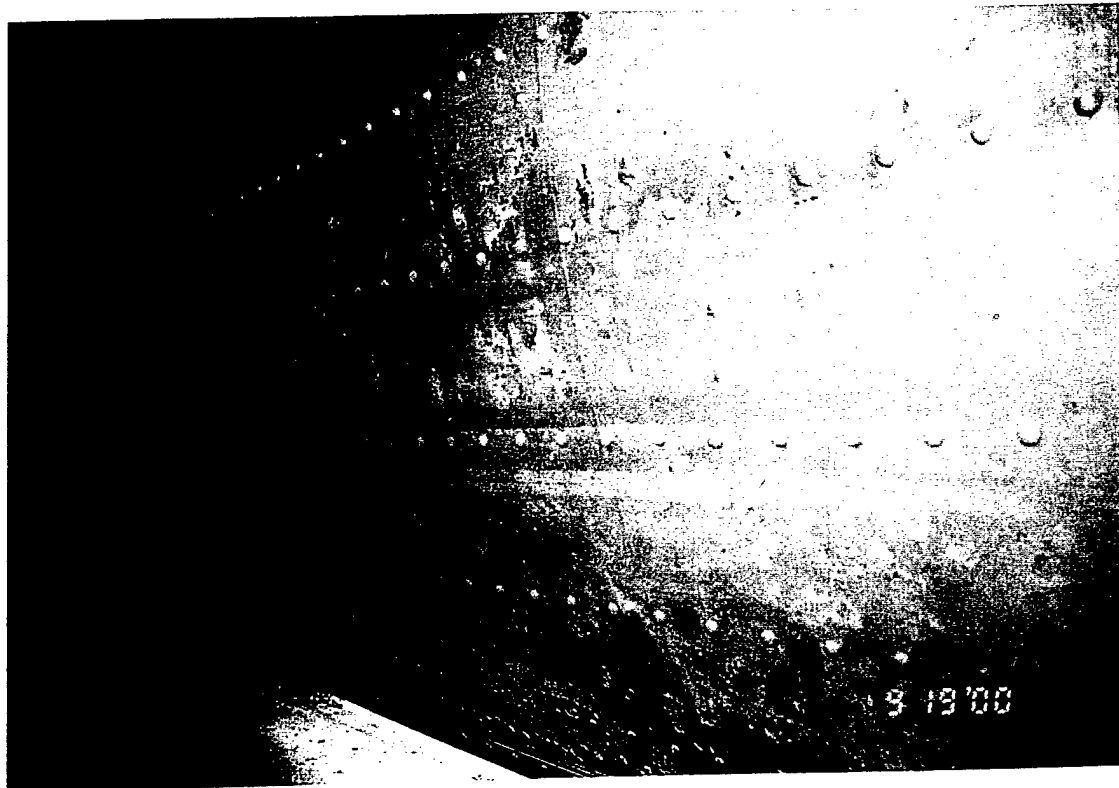
Gate 4 - 8'x18'  
Side seal and keeper bar from  
upstream. Peeling paint and light  
corrosion on skin plate.
